HAZARDOUS MATERIALS SURVEY

BUILDING 160
WHITE SANDS MISSILE RANGE

WSMR Contract No: DATM05-01-P-0221
WSMR Work Order No: P00007
VIVA Project No.: WSMR.14.1.36
Issue Date: July 30, 2002

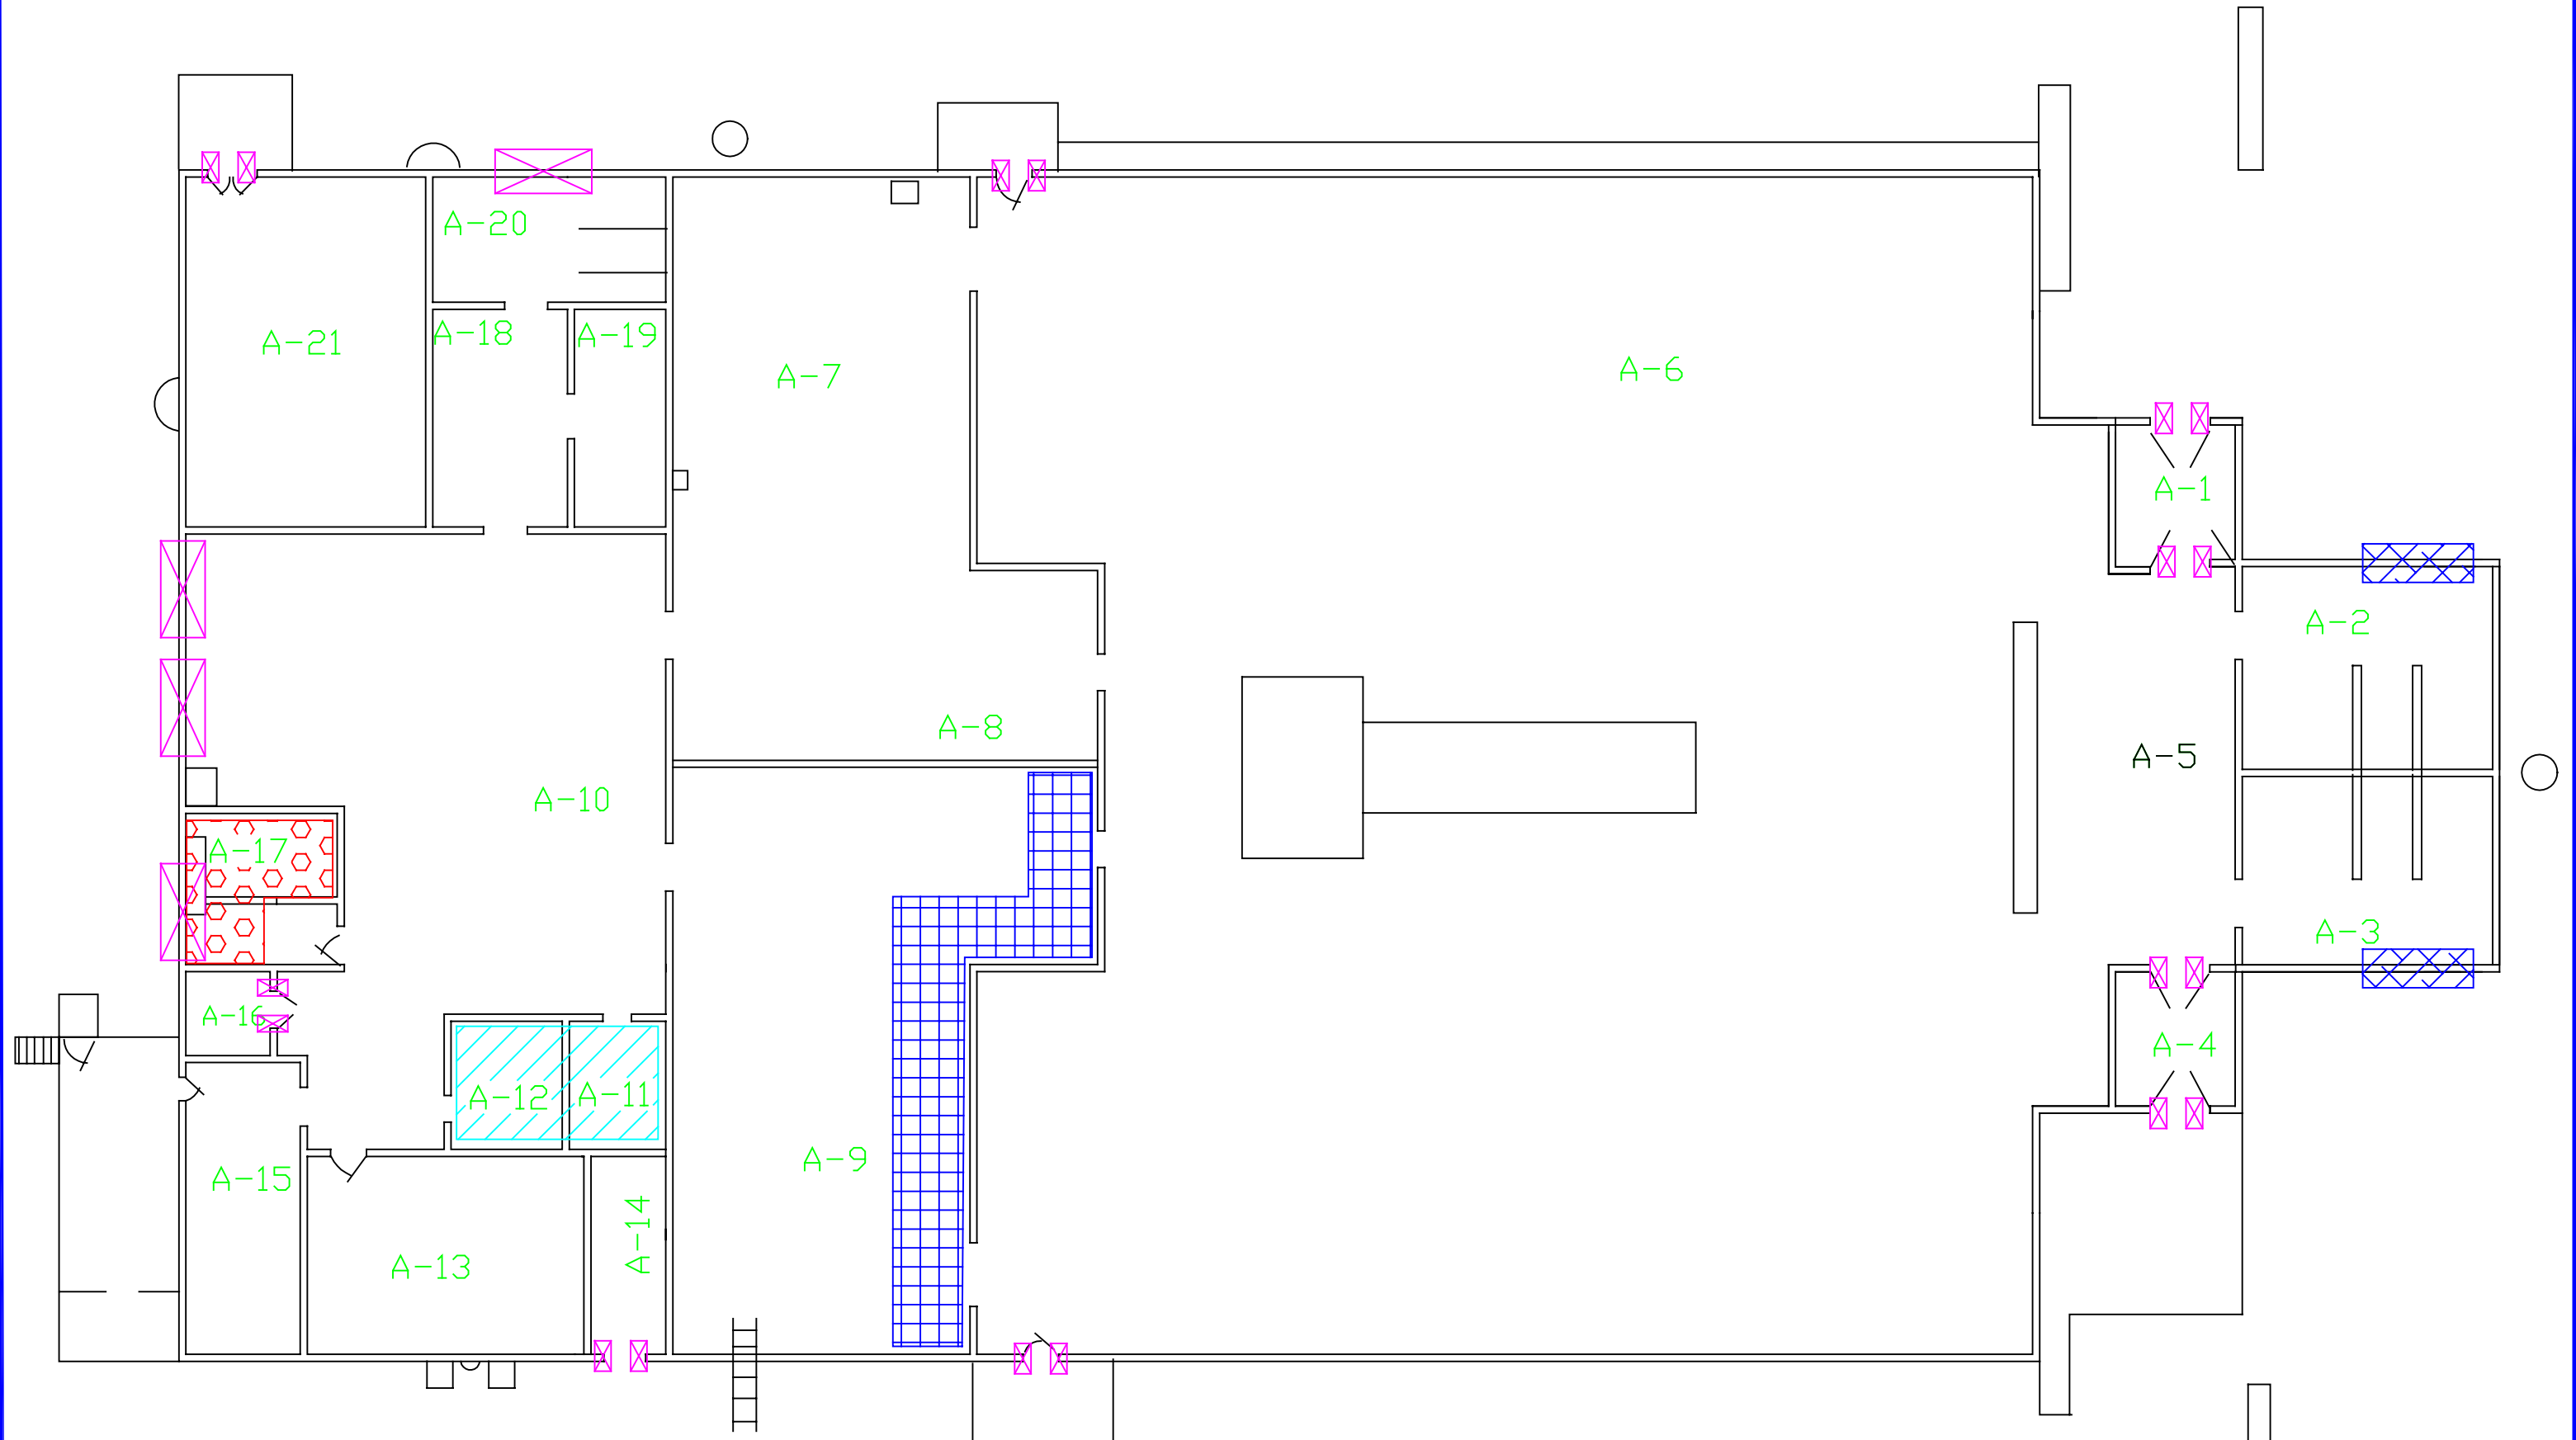
VIVA ENVIRONMENTAL, INC. 7201 STILES DR. EL PASO, TX. 79915		
NAME			BUILDING 160 ASBESTOS LOCATIONS WHITE SANDS MISSILE RANGE, N.M.		
DRAWING NO.			04		
SCALE:			NTS

HOMO #4 Black Insulation UnderPlastic Laminate on Ceilings
-

HOMO #11 Black Floor Tile Mastic
-

HOMO #16 Grey 9x9 Floor Tile
-

HOMO #23,25 Caulking
-

HOMO #33 Window Glazing

If Asbestos Containing Building Materials (ACBM) are to be disturbed, the procedures outlined in 29CFR Part 1926.1101 (OSHA regulations pertaining to worker protection) and 40 CFR Part 61 regulations (pertaining to visible emissions and notifications) must be followed.

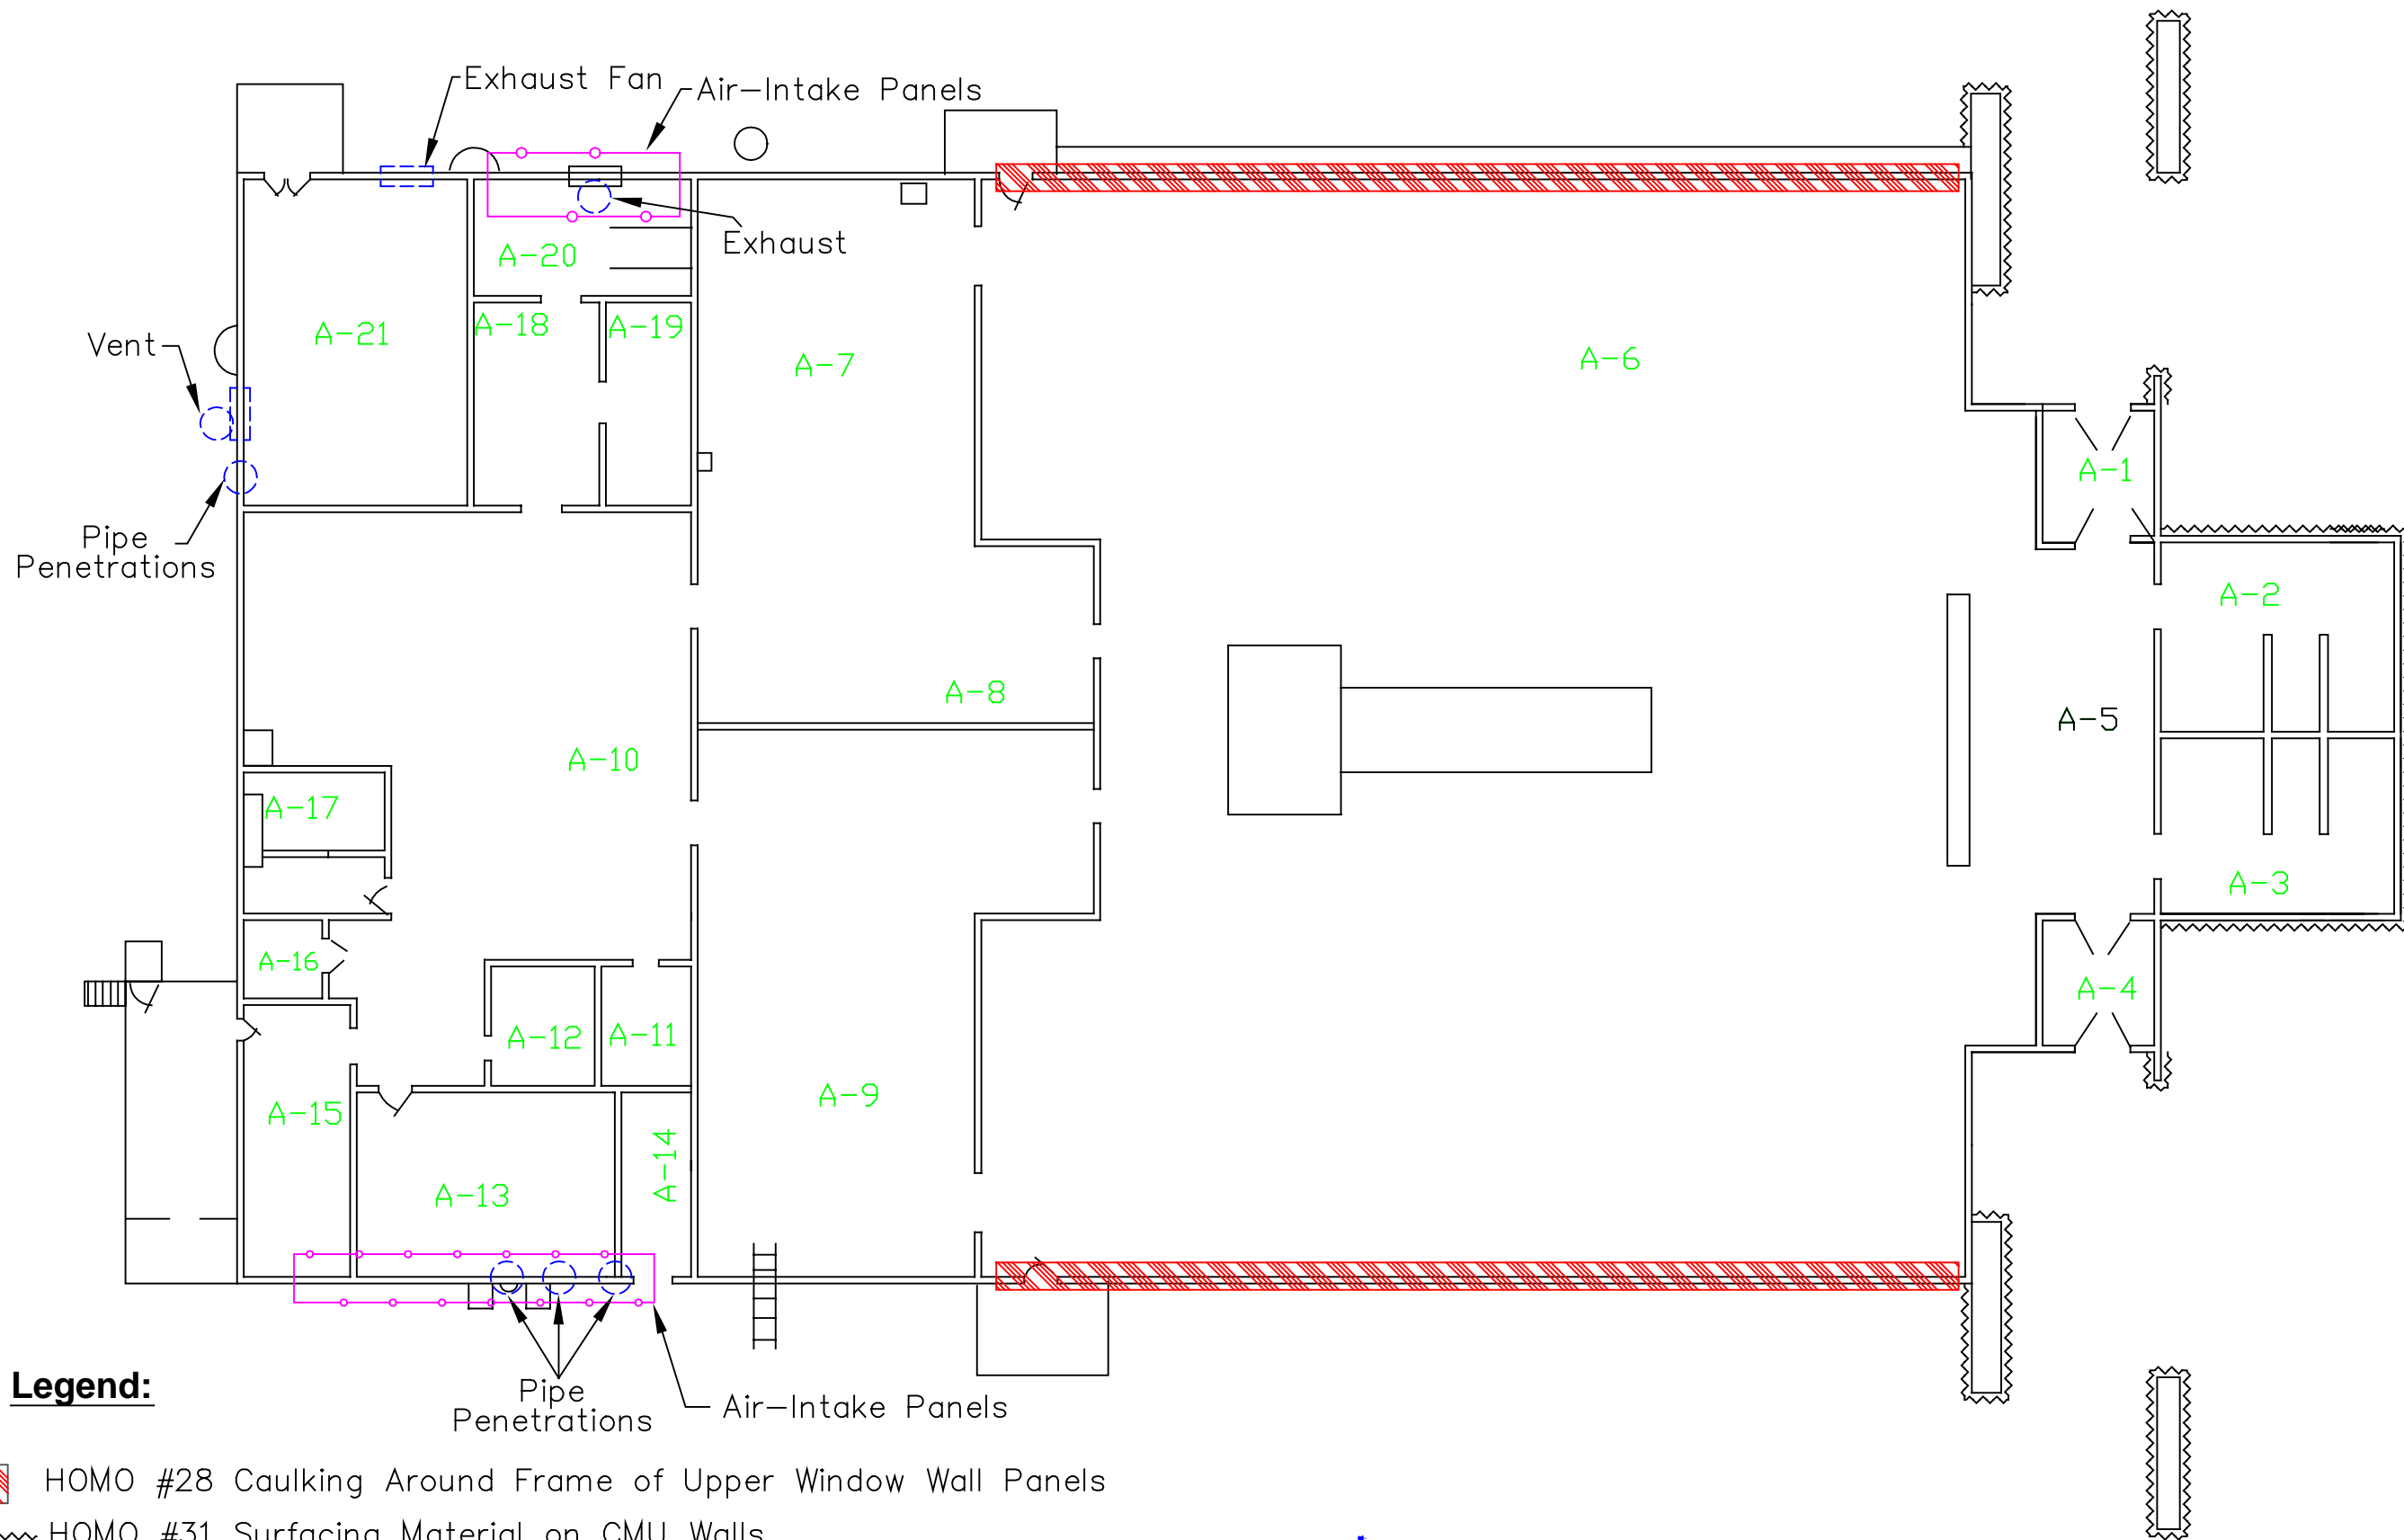
VIVA ENVIRONMENTAL, INC. 7201 STILES DR. EL PASO, TX.79915				NAME BUILDING 160 ASBESTOS LOCATIONS WHITE SANDS MISSILE RANGE, N.M.	
DRAWING NO. 05				SCALE: NTS

HOMO #28 Caulking Around Frame of Upper Window Wall Panels
-

HOMO #31 Surfacing Material on CMU Walls
-

HOMO #29 Caulking on Vents, Exhausts, and Pipe Penetrations
-

HOMO #43 Caulking Around Frame Of Air Intake Panels

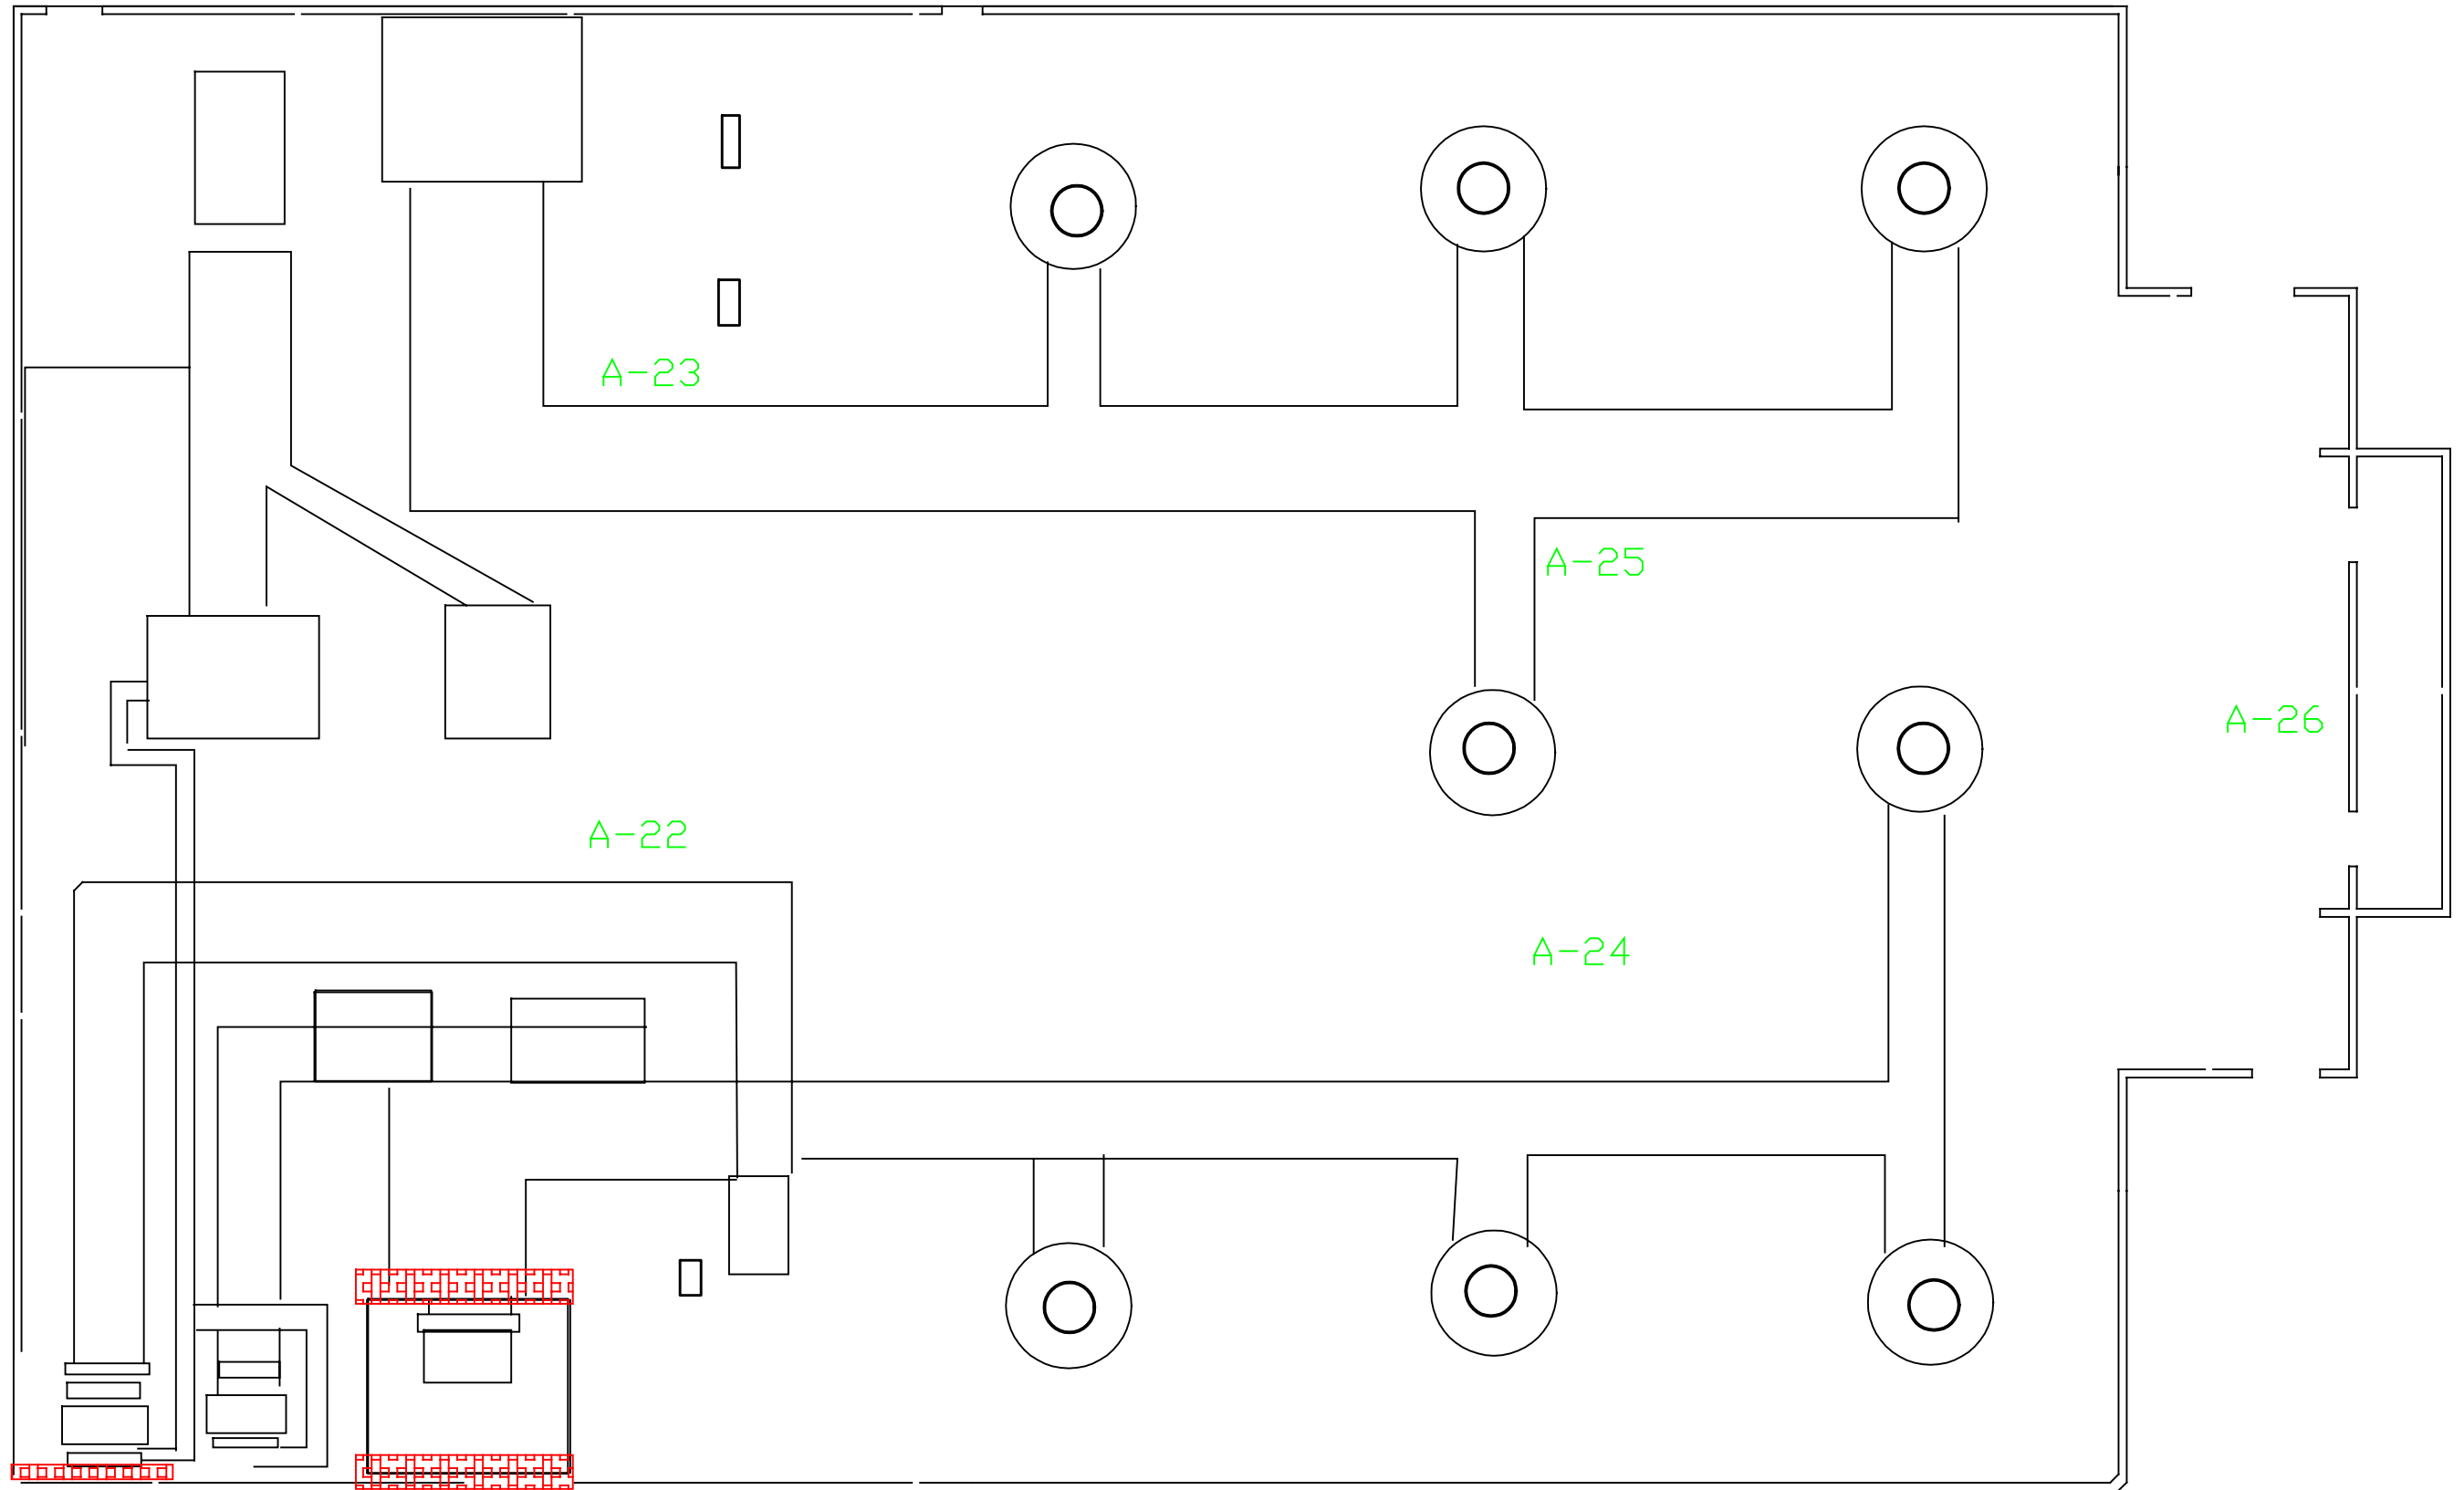
VIVA ENVIRONMENTAL, INC. 7201 STILES DR. EL PASO, TX.79915				NAME BUILDING 160 ASBESTOS ATTIC LOCATIONS WHITE SANDS MISSILE RANGE, N.M.	
DRAWING NO. 06				SCALE: NTS

HOMO #21 Caulking At Duct Work

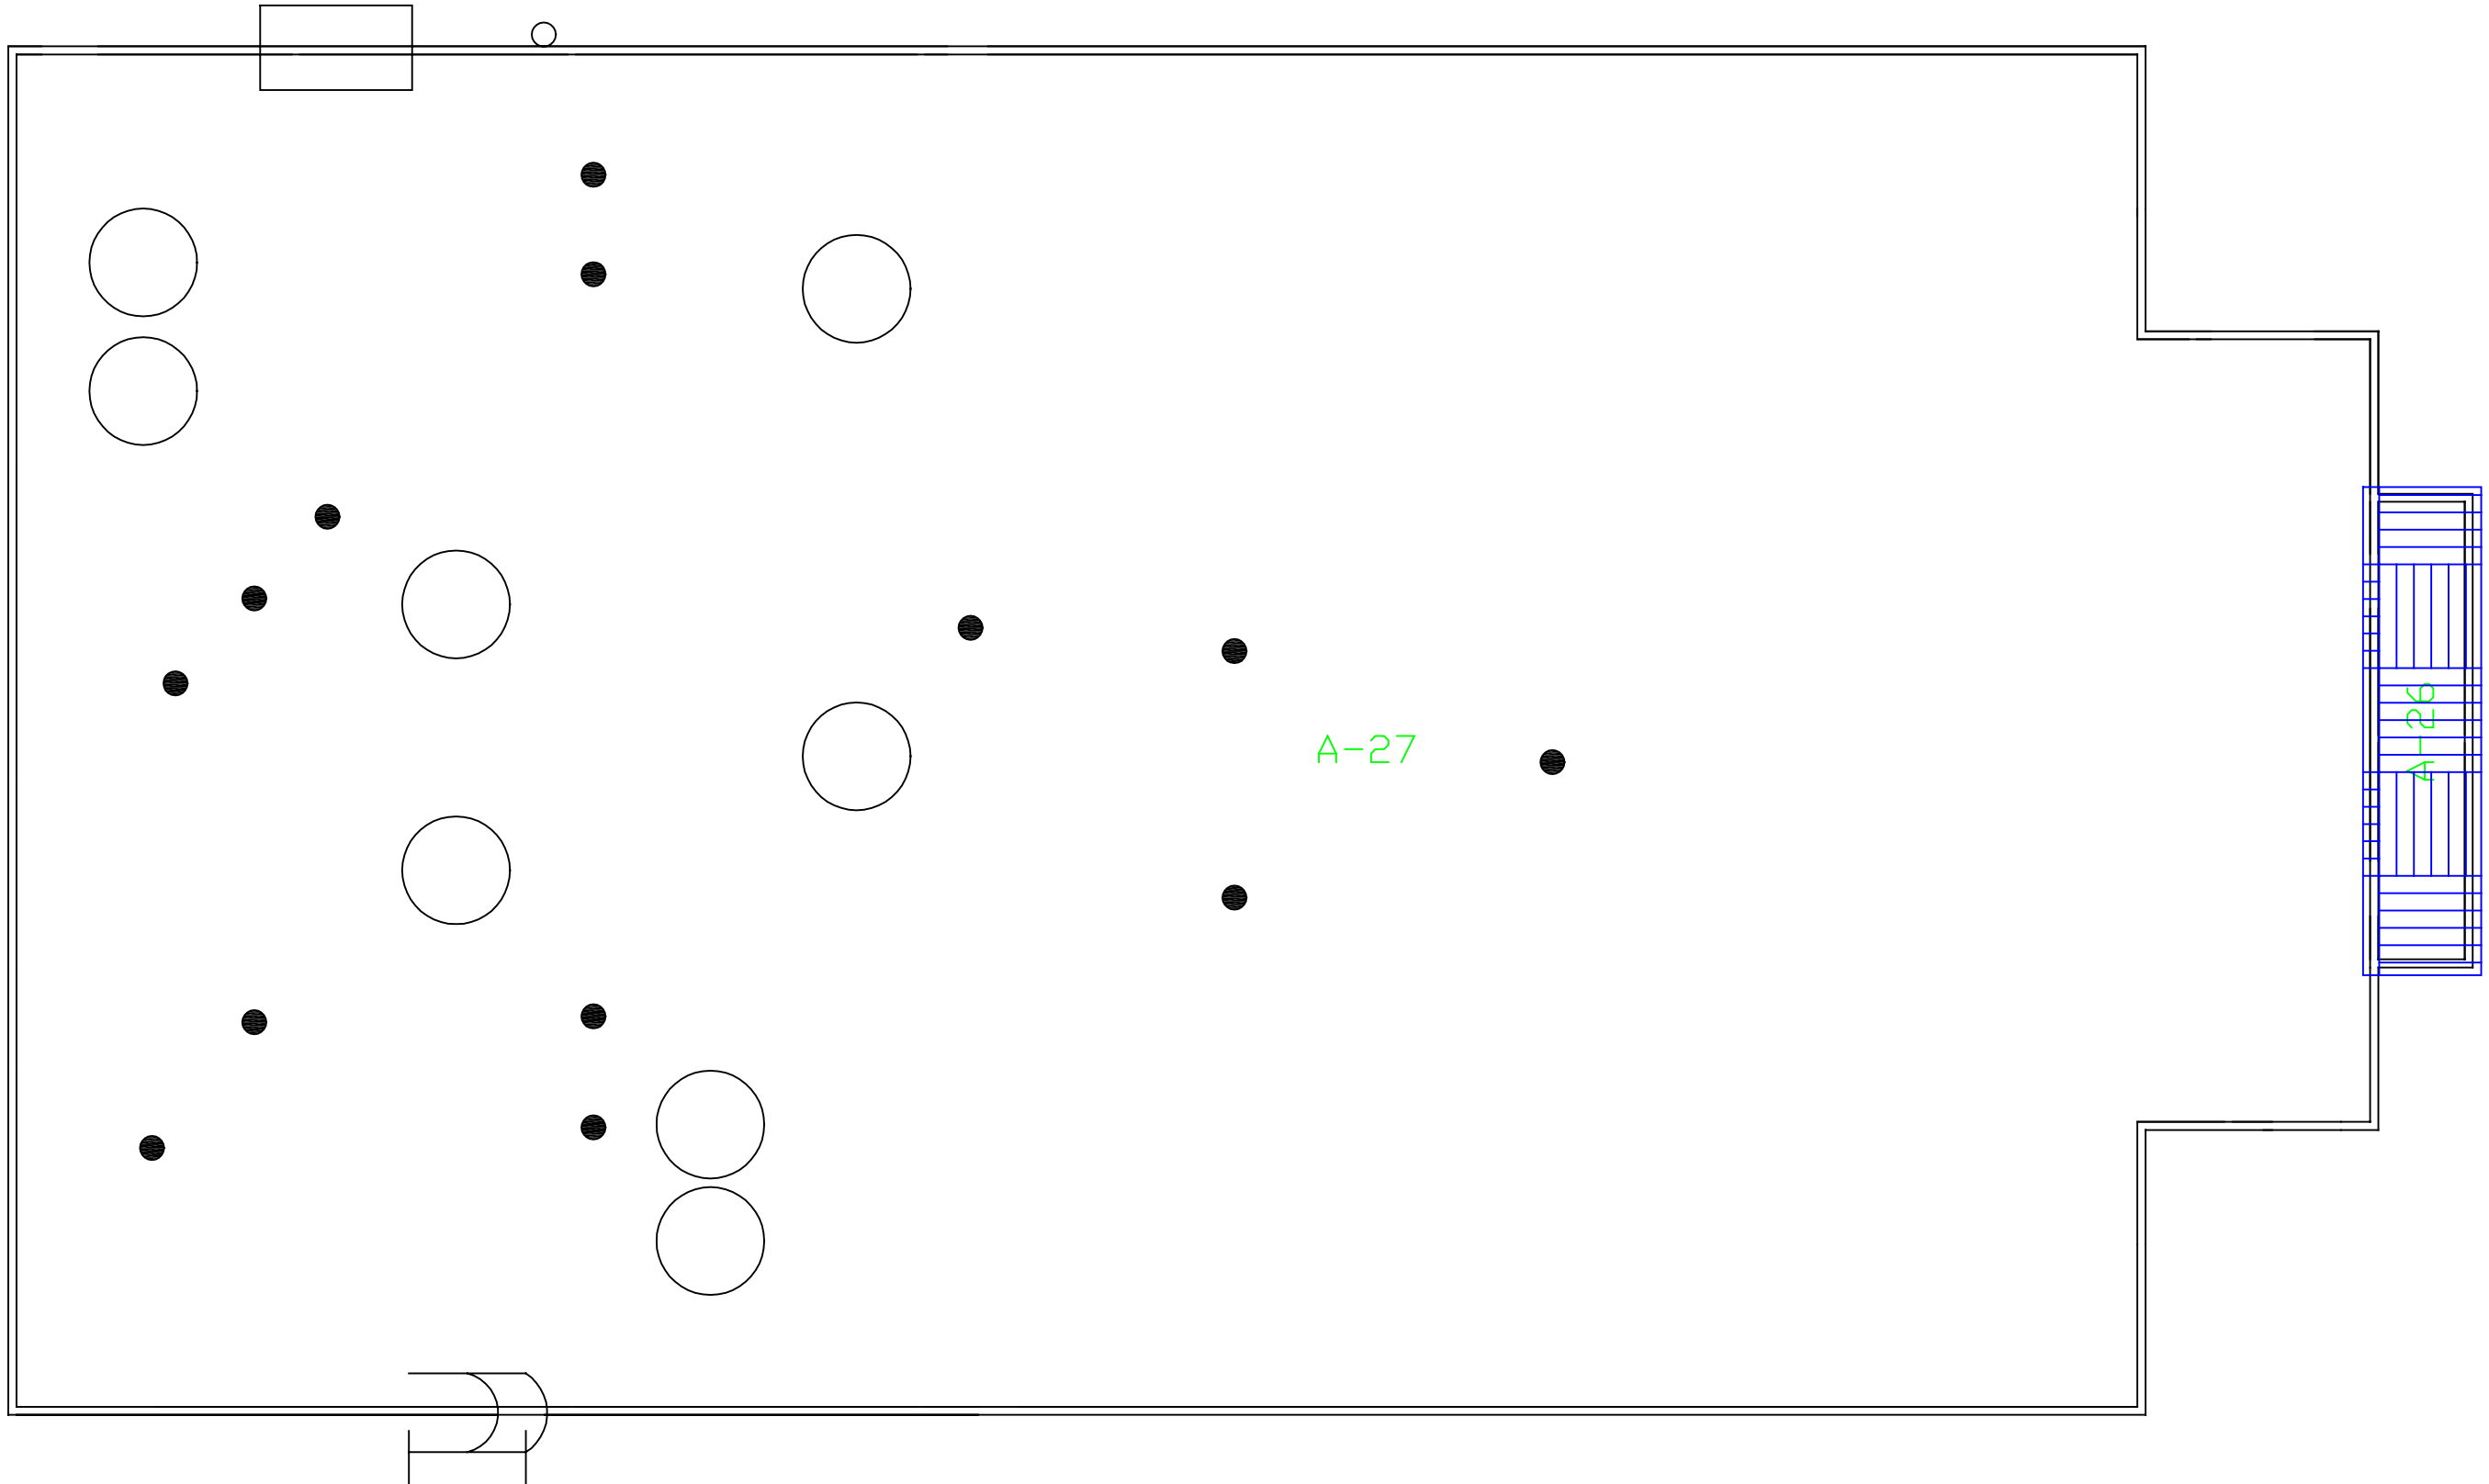
VIVA ENVIRONMENTAL, INC. <small>ENVIRONMENTAL, INC. The Future Is Clear! 7201 STILES EL PASO, TEXAS 79915</small>				NAME BUILDING 160 ASBESTOS ROOF LOCATIONS WHITE SANDS MISSILE RANGE, N.M.	
DRAWING NO. 07				SCALE: NTS

HOMO #45 Silver Paint Under Roof Membrane
